FORD FLYWHEELS

TO ASSURE PROPER CLUTCH OPERATION, PERFORMANCE, AND CLUTCH LIFE, THE FOLLOWING MUST BE CHECKED AND CORRECTED IF NECESSARY.

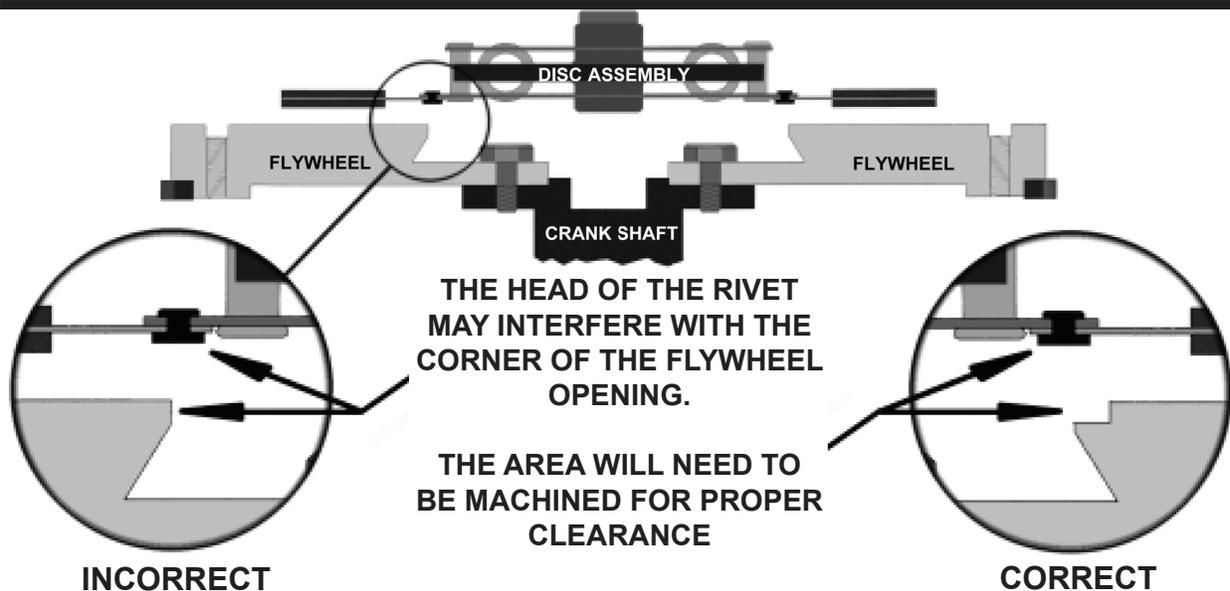
POSSIBLE INTERFERENCE MAY OCCUR BETWEEN THE CLUTCH DISC HUB TO MARCEL RIVETS DUE TO THE CENTER OPENING OF THE FLYWHEEL BEING INADEQUATE. THE RIVETS MAY RUB ON THE FACE OF THE FLYWHEEL. CAUSING THE ASSEMBLY TO RELEASE IMPROPERLY, MAKE NOISE DURING ENGAGEMENT, POSSIBLE FLYWHEEL AND DISC DAMAGE, AND/OR PREMATURE CLUTCH DISC FAILURE.

TO CORRECT THIS INTERFERENCE PROBLEM, A RELIEF MUST BE MACHINED INTO THE FLYWHEEL BY A QUALIFIED MACHINE SHOP. THE RELIEF SHOULD BE APPROXIMATELY .100" DEEP WITH SUFFICIENT DIAMETER TO CLEAR THE RIVET HEADS.
